4th international conference on  
shaft design and construction

**THE LARGEST FULLY LINED BLIND BORED VENTILATION SHAFT CONSTRUCTED TO  
DATE IN AUSTRALIA**

# **BLIND BORE SHAFT METHOD, SUCCESSFUL COMPLETION OF THE SOUTHERN COALFIELDS VENTILATION SHAFT**

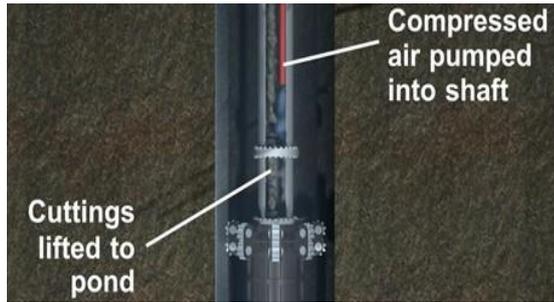
Figure 4. How pneumatic lift is created in drill string

Whilst drilling, rock fragments were transported from the face to the surface by a strong flow of water directed around the cutterhead and up through the centre of the drill rods before being discharged into the circulation ponds on the surface. Negative pressure was induced in the drill string by injecting compressed air via a small diameter air tube resulting in pneumatic lift and reverse water circulation causing the cuttings to be discharged into circulation ponds at the surface. After sufficient sedimentation time to allow the solids to fall out of the water, the water was then returned to the shaft by a return water pump to complete the circulation system. Figure 5 shows the discharge hose from the top of the drill string into the circulation ponds.

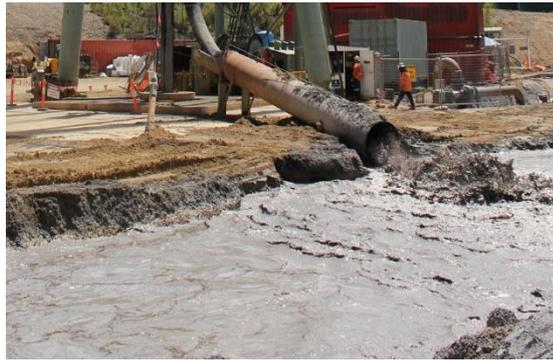
Figure 5. Hose discharging spoil into circulation pond

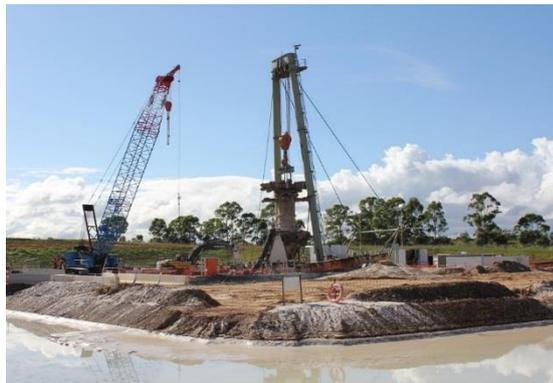
Figure 6. Process water in large circulation pond with drill rig

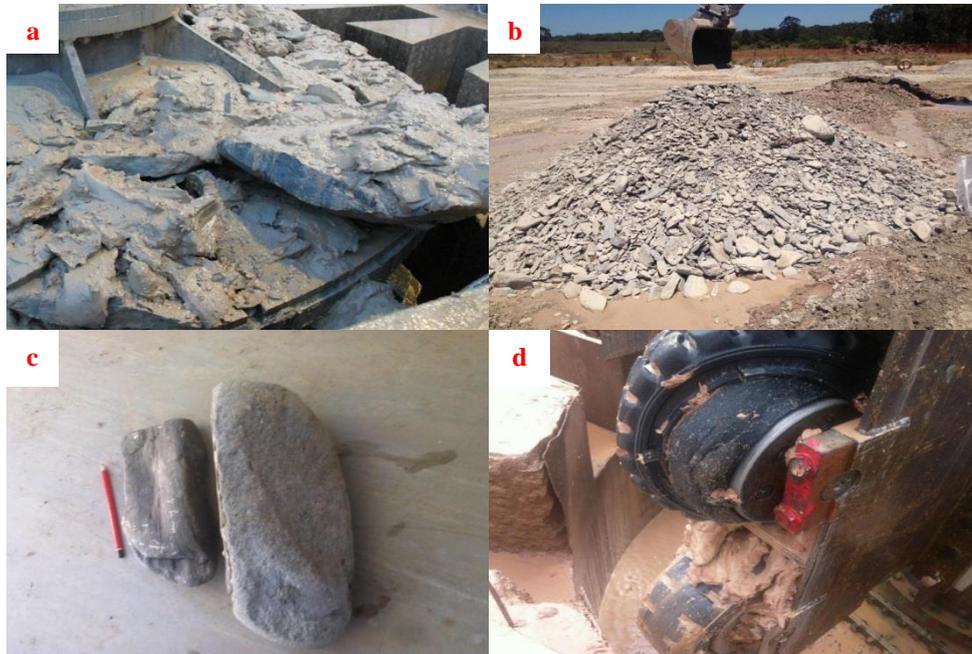
Figure 7. a) Rock debris recovered on drill head; b) Large unprocessed rock material recovered from circulation ponds; c) size of large rocks recovered in dams; d) damaged stabiliser tyres caused by loss of wall stabilisation resulting from voids in shaft walls

Difficult strata conditions presented complex challenges for the Abergeldie project team. Whilst drilling through the Bulgo sandstone found between 230 m–422 m the drill rig began to rock and bounce around more than usual. Based on rock samples recovered on top of the DHA and advice given by a Geotechnical Engineer it was determined that there was sizeable material coming away from shaft wall as a result of stress relieving.

The material coming away created voids in the shaft walls, preventing the DHA's lateral stabilisers from working effectively. This increased the rate of wear on the DHA cutters reducing the drilling penetration rate and also led to damage of the stabilisers when contact was lost with the wall of the shaft.

Large pieces of material fell down from the shaft walls towards the drilling face and those that did not come to rest on top of the drill head were very difficult for the cutters to break up into fragments small enough to be removed by the reverse circulation process. The large fragments tended to build up around the cutters as they tried to work their way down the drill head towards the evacuation point at the tip of the drill head holding the DHA back from the excavation face and inducing additional torque. Like marbles rolling around on a smooth floor, the fallen rock would simply be pushed around and moved out of the way of the cutters, rather than being broken down. Figures 7a–7d further illustrate the difficulties encountered.

Once the effects of shaft wall voids on the drilling process were understood, the project team began to develop an alternative methodology to deal with the specific strata conditions encountered. To counteract the loss of stabilisation and improve cleaning of the fallen material from the shaft floor, tooth cutters were installed on the cutter head. The tooth cutters provided a larger, more stable, platform for the DHA working like a sheep's foot roller in breaking up the loose material.

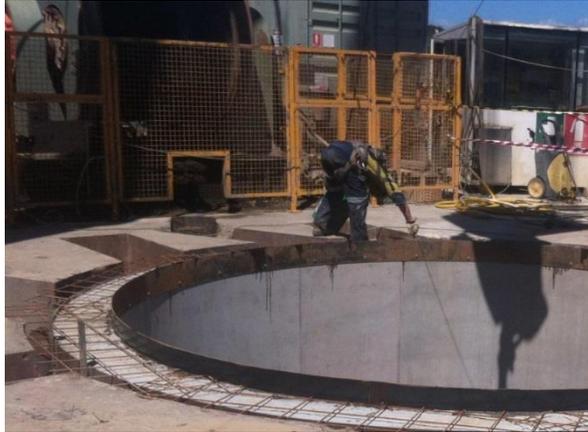
Figure 9. Setting up to cast the liner into position prior to bailing out shaft

Once the shaft lining had been installed and grouted, the plug was drilled out and the water was removed from the shaft. Testing with a piezometer from the shaft surface confirmed there was no water left in the shaft at the conclusion of the bailing operation.

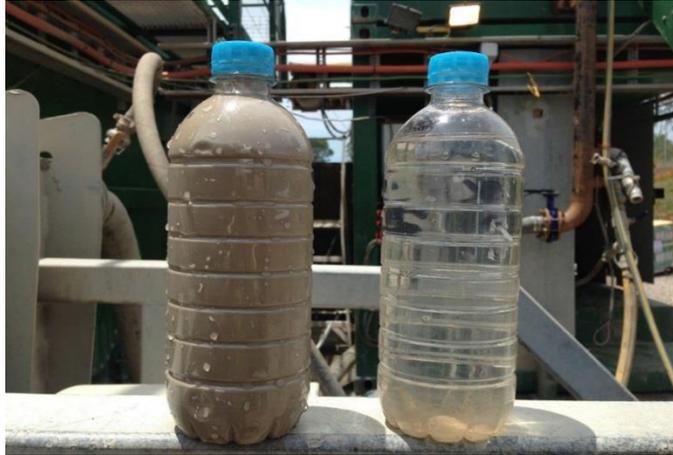
Figure 10. Process water before and after treatment

After many months of painstaking trials of several methods to treat the 18 million litres of drilling process water to reach quality acceptable for discharge, the project team adopted a very effective process. The water treatment process involved injecting a flocculant solution into the drilling water upon entering a centrifuge. The flocculant solution when mixed with the drilling water attracted the smaller suspended solids to form larger clumps which were then removed by the centrifuge.

This treatment process solution was highly effective at reducing turbidity levels to below the discharge limits. Figure 10 illustrates the process water before and after the treatment cycle.

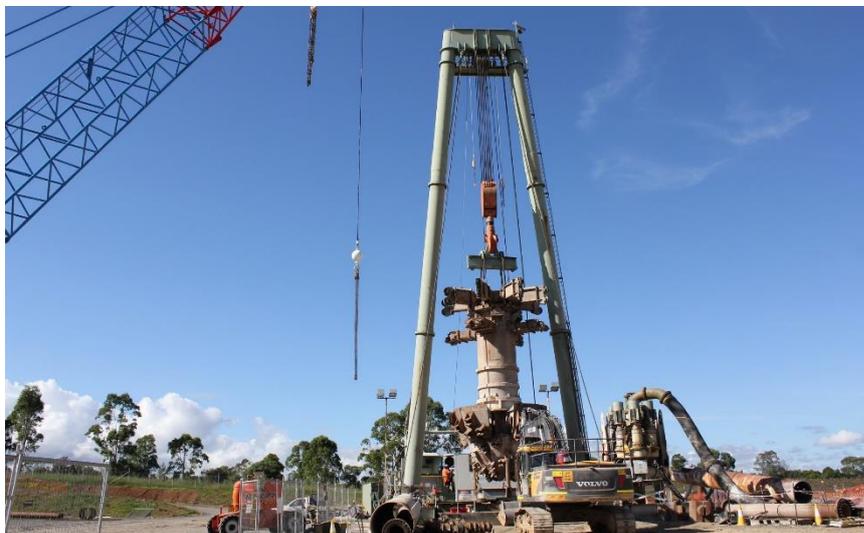
Figure 11. Drill rig with drill head raised
